Manhole Inspection Summary

Manhole # S35KK_048MH

Insp Date: **3/8/07 3:35 PM**

Location Address: **301 NORTH AVE**

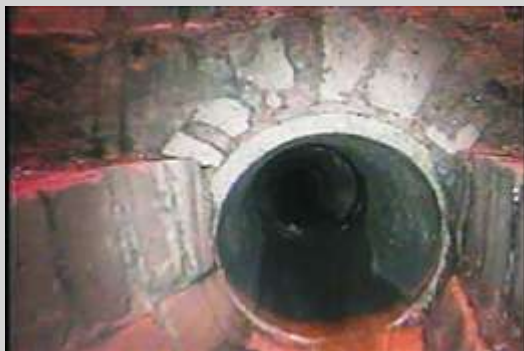
8 in. Circular Gravity Sewer Pipe In @ 3 O'Clock

Pipe Material: **Clay** ☐ Pipe Lined

Infiltration: **None** Pipe Seal Cond: **Unknown**
